CASE  
STUDY

# Ecosystem Services contributing to nature based solutions for disaster resilience

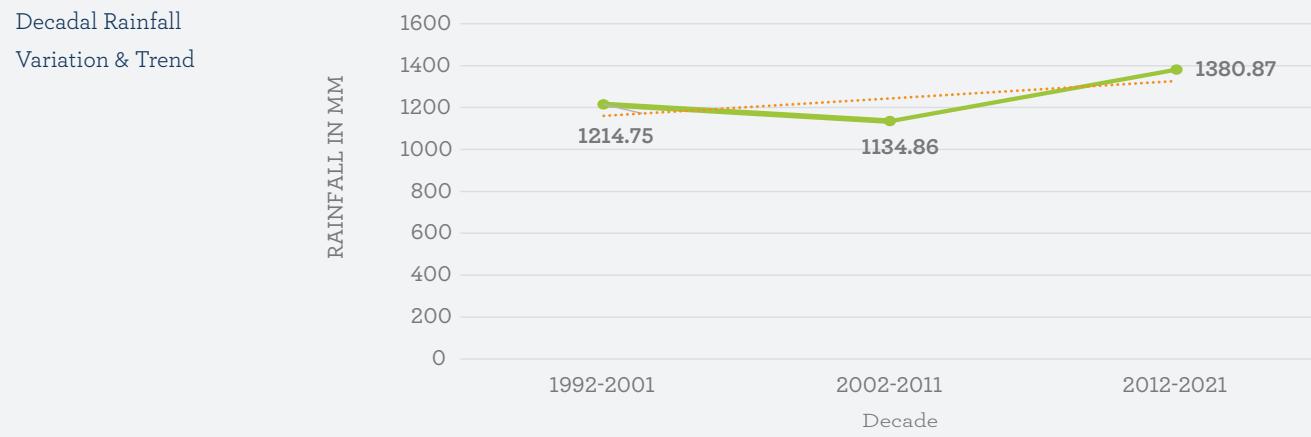
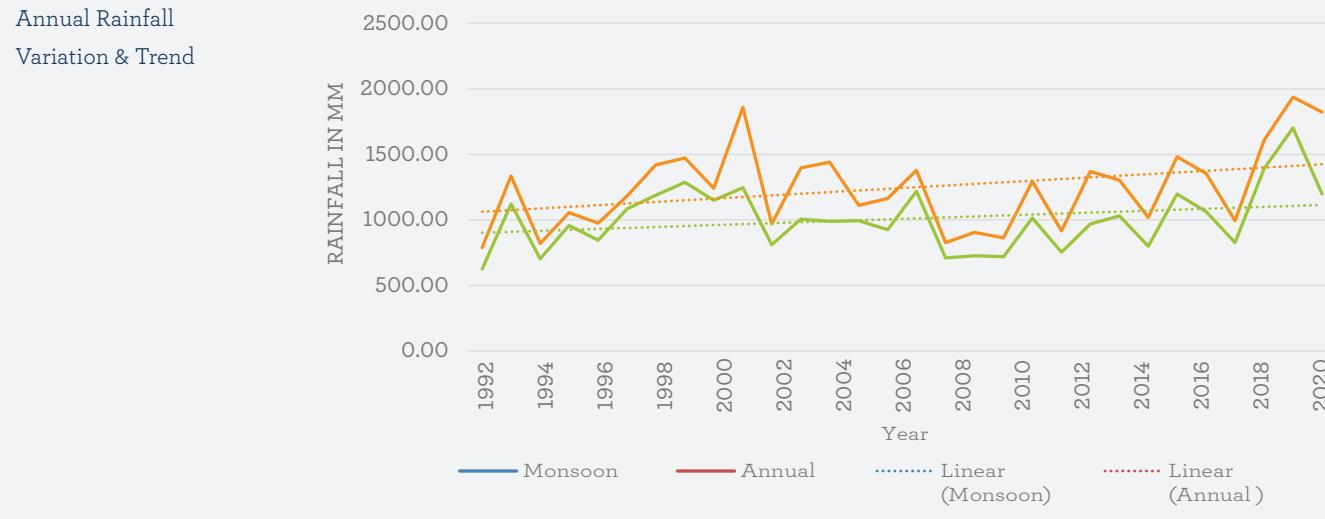
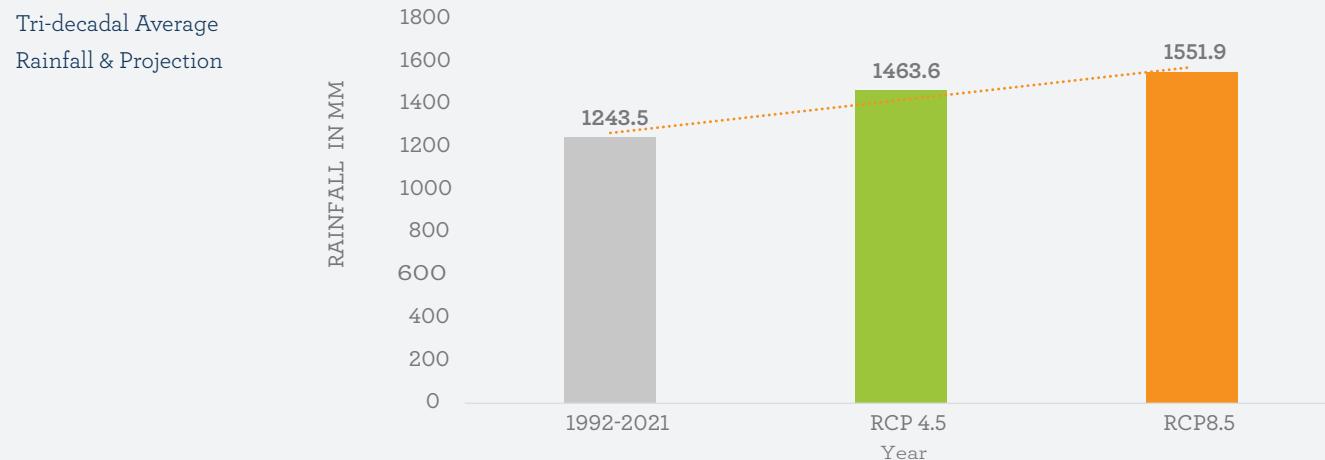
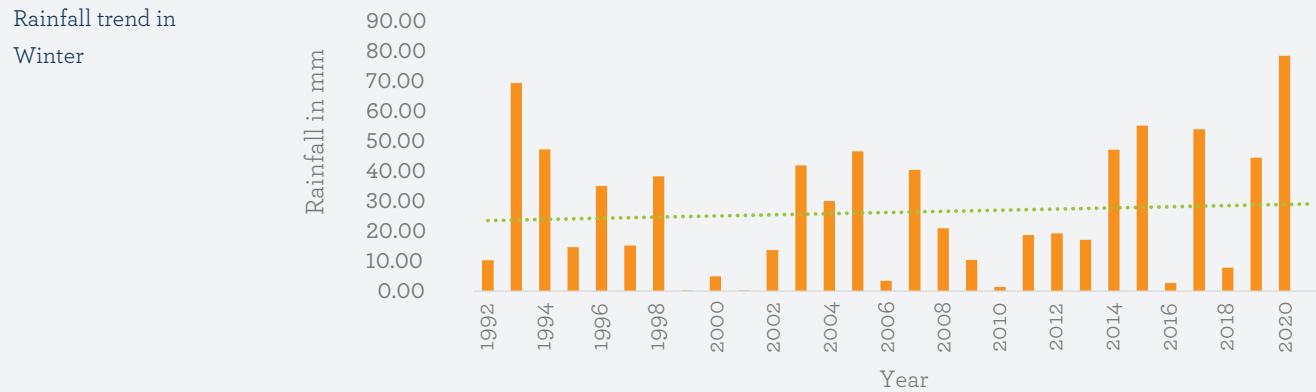
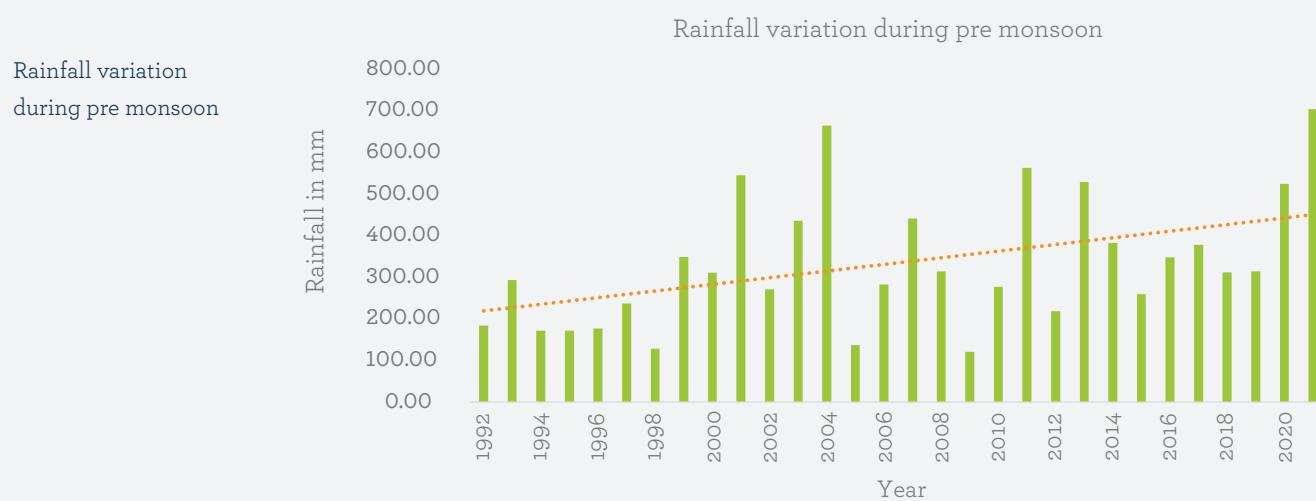
### Time series of rainfall in mm for the southwest monsoon season and annual and trends

- Average Annual rainfall of the district is 1243 mm. The last decade 2012-2021 has experienced significant increase trend in annual rainfall .
- By the mid of 21 century , the tri-decadal rainfall is projected to increase significantly from 1243 mm to 1551.9 mm

- Annually the district experienced increasing rainfall trend with highest rainfall in July. But in last 30 years average rainfall in pre-monsoon has shown significant increasing trend
- In last 30 years, the contribution of pre monsoon (April–June) rainfall has increased from 21.14 % (1992–2001) to 28.76 % ( 2012–2021)

- In last 30 years ( 1992–2021) the frequency of heavy rainfall is increasing.
- The years 2020 and 2021 have highest extreme rainfall events
- During 2021–2050 the frequency of heavy rainfall days is projected to be increased to 51.2 and 55.9 days in two different scenario i.e RCP 4.5 and RCP 8.5 respectively.

- In comparison to other parts of the state , the district Supaul is experiencing significantly declining trend in maximum and Average temperature
- In last 30 years, the Maximum temperature has declined from 34 degree centigrade to 31 degree temperature.
- It is also important to note that in the district the frequency of warm days has also declined from 68 days to less than 20 days in last 30 years

- Both Maximum and Minimum temperature is projected to decline in both the scenario i.e RCP 4.5 and RCP 8.5 by mid-century (2050).

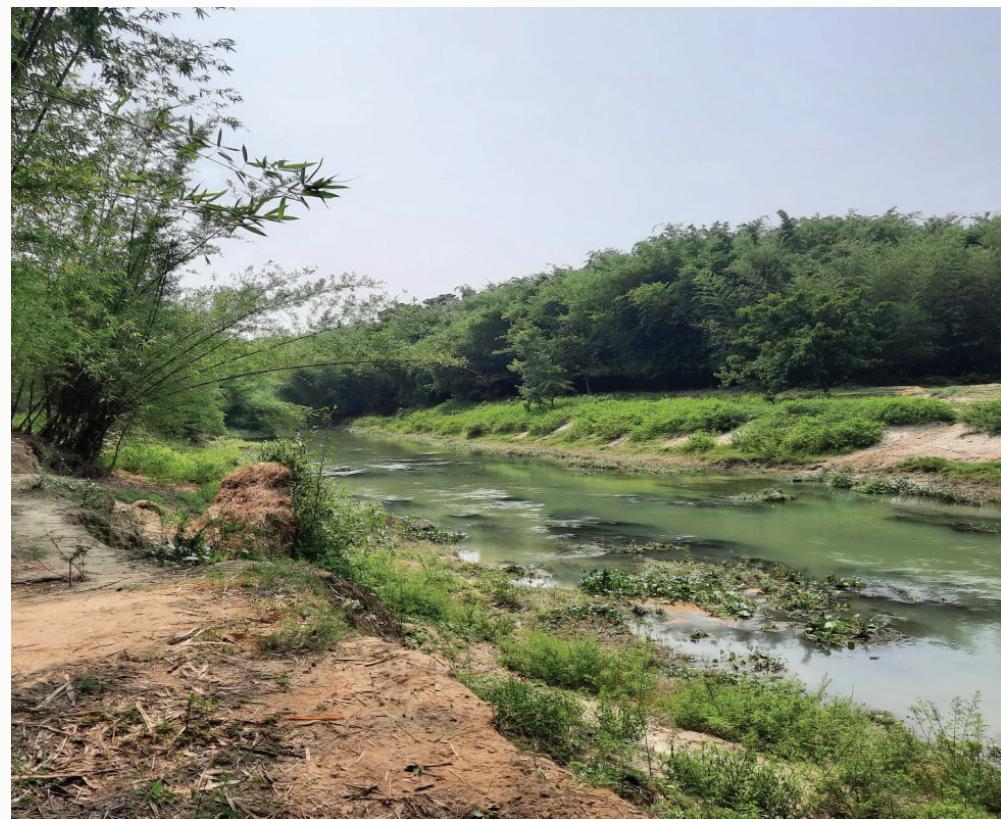
Tiljuga is a tributary of the Kosi River, which originates in Nepal. Flowing through Bathnaha village in the project area, it takes an eastward course after touching Sikarhatta/Chutiyahi village. During the monsoon, the river acts as a natural drainage channel, taking in excess runoff from the Kosi River. However, its drainage capacity is affected due to the sandy deposits and siltation, which comes along with the Kosi river. Despite this, the river is capable of mitigating the flood effects. Residents of Sikarhatta and Bathnaha reported that there was a breach in Grameen Bandha/village bund during the monsoon of 2021. Water was flowing profusely in the Kosi river, creating panic among the inhabitants. However, no major damages were caused since the Kosi river followed the course of the Tiljuga river, allowing the floodwaters to flow downstream.

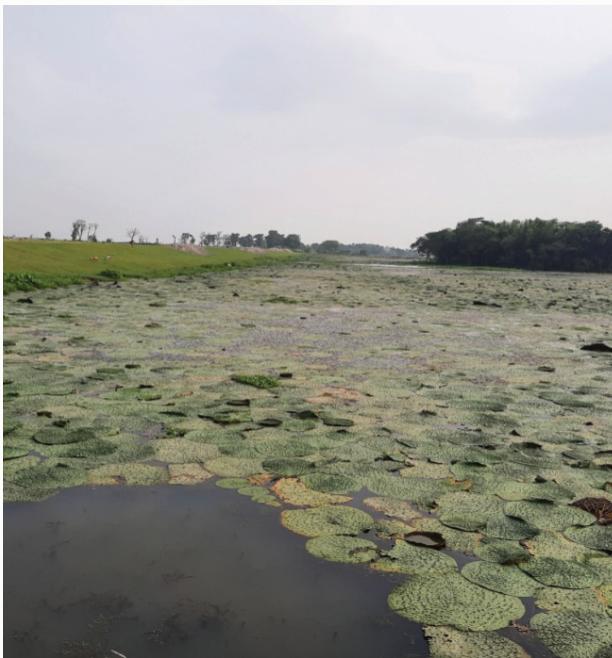
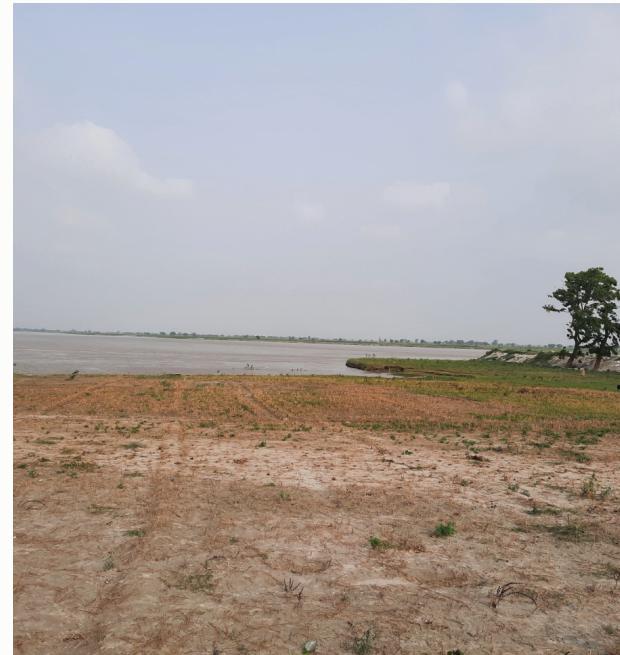
Kosi river is on the left side of Paschimi Tatbandh and the natural water stream which flows along

A wide natural water stream is located in Bathnaha village, which flows along the Pachchimi Tatbandh (Western Embankment). The stream flows one and a half kilometers downstream. While acting as a water reservoir, the stream helped control seepage caused by embankments. During heavy rainfall, it absorbed excess runoff to prevent floods in adjacent areas. The community members of Sikarhatta village shared that the water stream protected them by draining excess flow from the Kosi river. Eventually, the stream merged with the Tiljuga river, and together they helped dissipate floods.

The stream is now in a degraded state with a significantly restricted flow. There is a large patch of land along the stream that has been encroached upon by the displaced people and the stream itself is filled with waste. Moreover, silt deposition from the Kosi river has reduced the natural capacity of percolation, resulting in water logging in nearby villages. During heavy rainfall, the water level in the stream rises and inundates the surrounding areas.

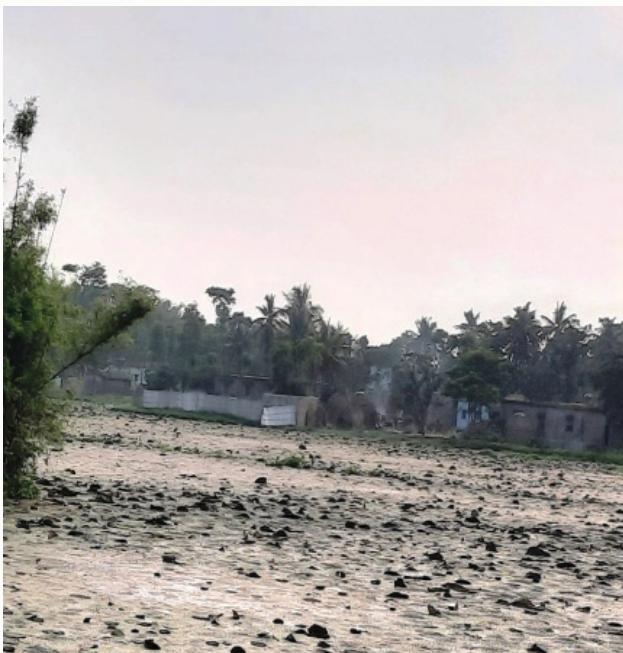
The village situated close to the stream faces water logging throughout the year

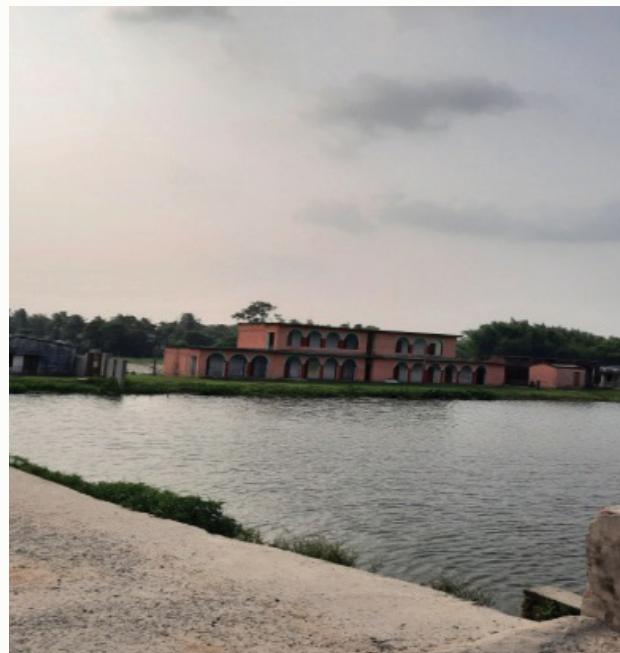
During heavy rains, water submerges the government school building

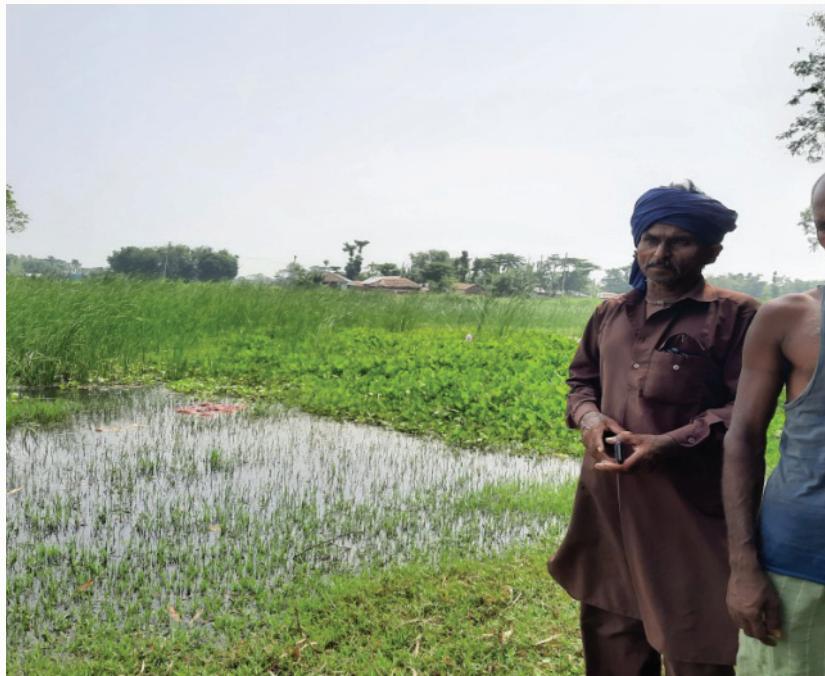
Farm land which is adjacent to the stream is water logged in the month of May 2022. During rainy season the land gets inundated in flood water.

Another stream of water can be found at Bela Singar Moti, which is seven to eight kilometers long and covers five to six Gram Panchayats. Due to poor maintenance and blockages, the stream is in a degraded state as invasive aquatic plants and weeds choke it. Along with this, the stream has also become a source of seepage, which

has significantly impacted crop production in the village. According to residents, the stream is now a breeding ground for snakes.
